Historic Lighthouse Preservation Handbook

1997

PD-375

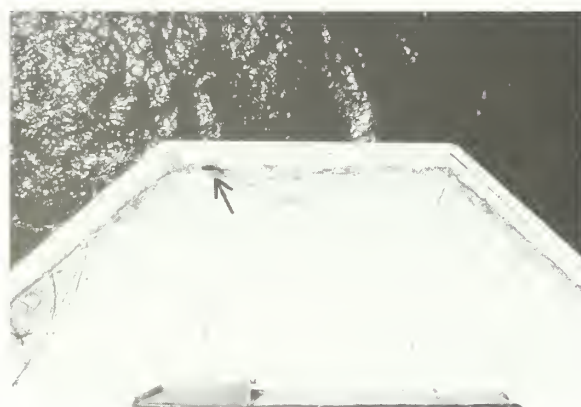
Figure 8. View of a wood-framed lighthouse roof; the arrow indicates where a large hole (approximately 2 by 4 inches) is present in the built-in gutter system. Water entering this hole has caused extensive damage to the interior wood framing members and wood interior wall paneling.

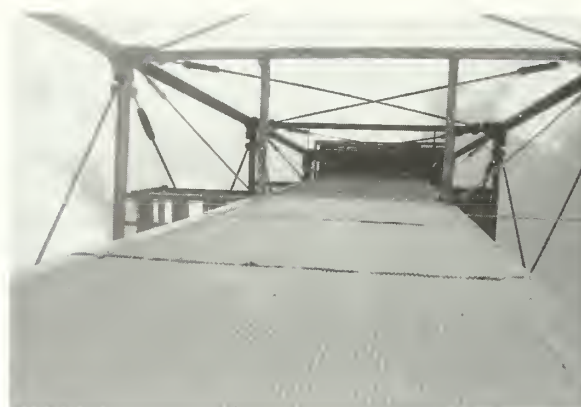
Figure 9. If the exterior of the wooden tower has been covered with another sheathing material like this corrugated metal, all joints in the exterior sheathing should be made completely weathertight; at this particular lighthouse, deterioration of interior wood framing members was caused by moisture infiltration.

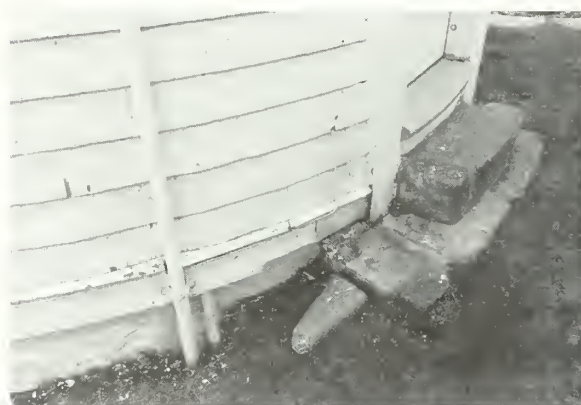
Figure 10. This door sill has a positive slope to ensure proper drainage; the joint where the door surround meets the shingles should be checked for gaps and recaulked if necessary.

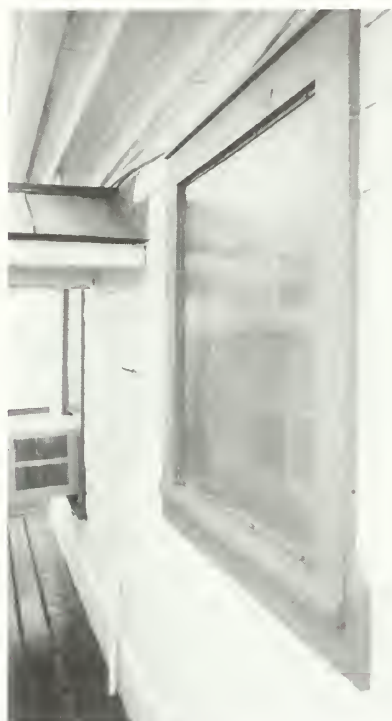
Figure 13. This image shows a Class I paint condition: virtually no deterioration, only some soiling and possible salt buildup resulting from the open-water location of the lighthouse.

Class I: Generally no paint removal—dirt, soot, pollution, chalking, mildew etc., (see Figure 13).

Recommended Treatment: This condition presents a problem only if the surface is to be painted over. If not removed, the surface deposits can be a barrier to proper adhesion and cause peeling. Most surface matter can be loosened by a strong, direct stream of water from the nozzle of a garden-type hose. Stubborn dirt and soot will need to be scrubbed off using a 1/2 cup of household detergent in a gallon of water with a medium soft-bristle brush. (For the removal of mildew add 1 cup of bleach to the non-ammoniated detergent.) The cleaned surface should be thoroughly rinsed and permitted to dry before further inspection to determine if repainting is necessary.

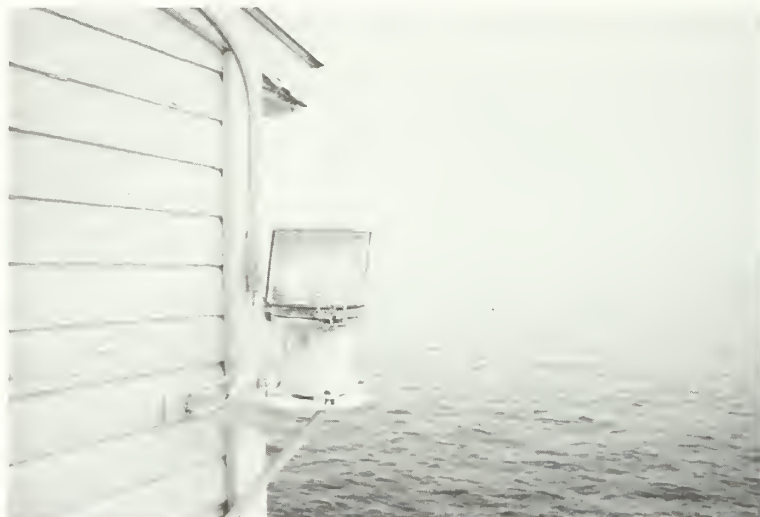
Class II: Generally limited paint removal—crazing, intercoat peeling, solvent blistering, wrinkling (see Figure 14).

Figure 14. View of Class II paint condition: this example happens to be on the same lighthouse as the Class I condition shown in the previous image; multiple paint conditions can exist on the same lighthouse. In this example, only spot paint removal and repainting will be required to remedy the condition.

Recommended Treatment: Crazing can be treated by sanding the surface by hand or mechanically, then repainting. Although hairline cracks may tend to show through the new paint, the surface will be protected from moisture penetration.

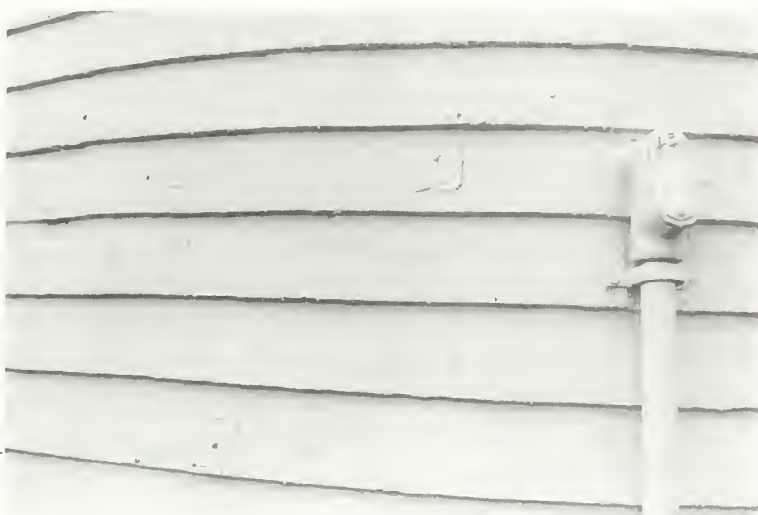
Class III: Exterior surface conditions generally requiring total paint removal—peeling, cracking/alligatoring (see Figure 15).

Figure 15. View of Class III paint condition: in this case the cracking, peeling, and alligatoring have been caused by excessive paint layer build up.

Cracking/alligatoring: Advanced stages of crazing. Once the bond between layers has been broken because of intercoat paint failure, exterior moisture is able to penetrate the surface cracks, causing the wood to swell and deeper cracking to take place. This process continues until cracking, which forms parallel to grain, extends to bare wood. Ultimately, the cracking becomes an overall pattern of horizontal and vertical breaks in the paint layers that looks like reptile skin; hence, ‘alligatoring’. In advanced stages of cracking and alligatoring, the surfaces will also flake badly.

Recommended Treatment: If cracking and alligatoring are present only in the top layers, they can probably be scraped, sanded to the next sound layer, then repainted. If cracking and/or alligatoring have progressed to bare wood, however, and the paint has begun to flake, it should be totally removed. Methods include scraping or paint removal with the electric heat plate, electric heat gun, or chemical strippers, depending on the particular area involved. Bare wood should be primed within 48 hours, then repainted.

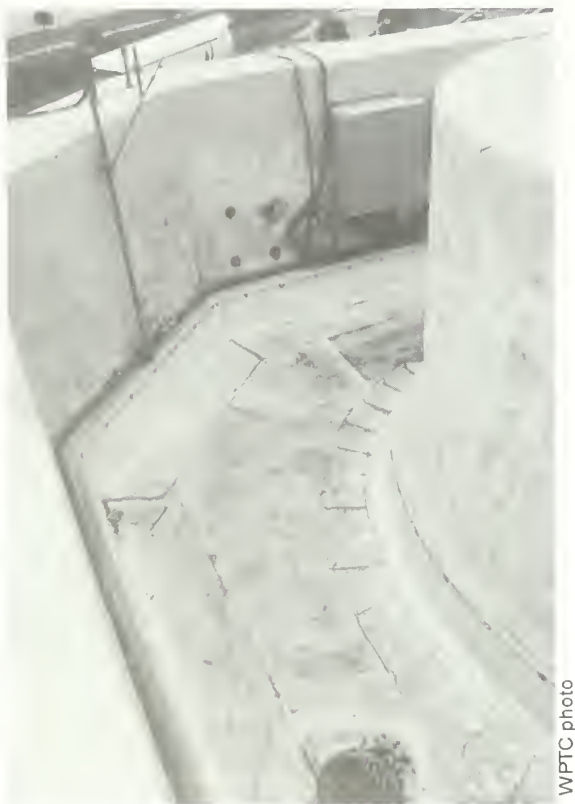
Figure 7. The concrete gallery deck on this concrete lighthouse has been covered with a rubber membrane. This covering should be checked regularly for leaks.

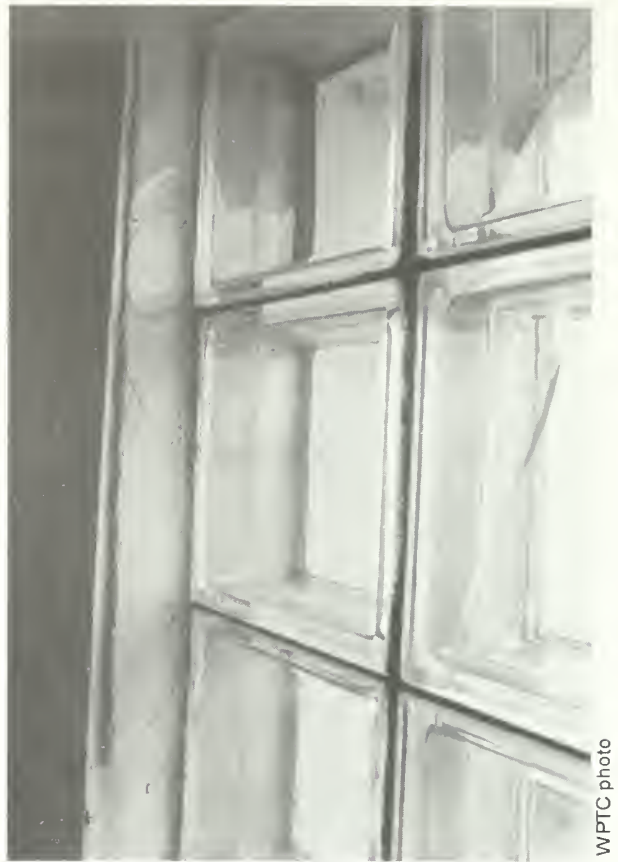
Figure 8. Close-up view of a glass-block window in a concrete lighthouse. The joint where the glass block meets the concrete wall should be caulked to prevent moisture infiltration.

- **Door and window frames:** The joints along the perimeter of doors and windows where a wood or metal frame is fitted into a concrete opening should be caulked to prevent moisture from entering the walls. See the **Windows** section for the proper caulk for this application.

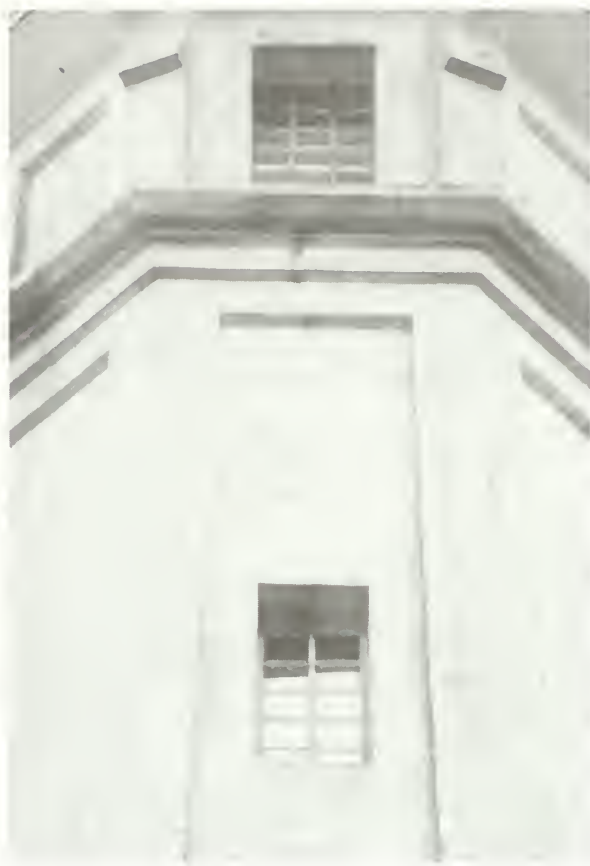
Figure 10. Cracks like the one here, extending down from the belt course of this concrete lighthouse, should be monitored for movement before any patching is performed.

- **Open cracks in walls:** Cracks in exterior concrete walls indicate that movement has

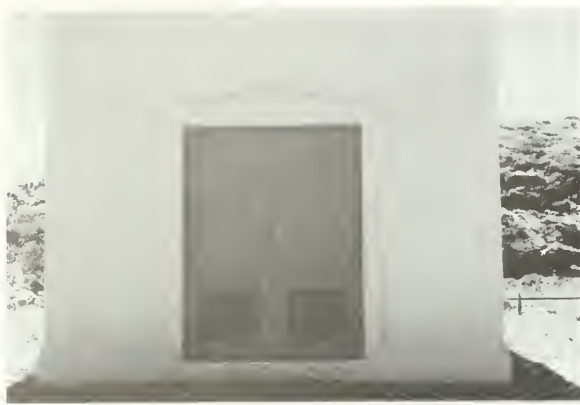
Figure 11. These replacement lighthouse doors have screened louvers that cover approximately 25% of the door opening to maximize air exchange.

Much like masonry lighthouses, concrete lighthouses are difficult to ventilate without resorting to extensive louvering and/or mechanical exhaust fan systems. During the summer months concrete lighthouses will need to have maximum air exchange to eliminate damaging condensation on the interior walls and woodwork and iron components. In order to achieve this, almost every window opening will need to be fitted with some type of passive louvered ventilation. Installation of window-mounted passive louver systems is covered in the **Windows** section of this handbook. For more information on lighthouse ventilation refer to the **Interiors** section.

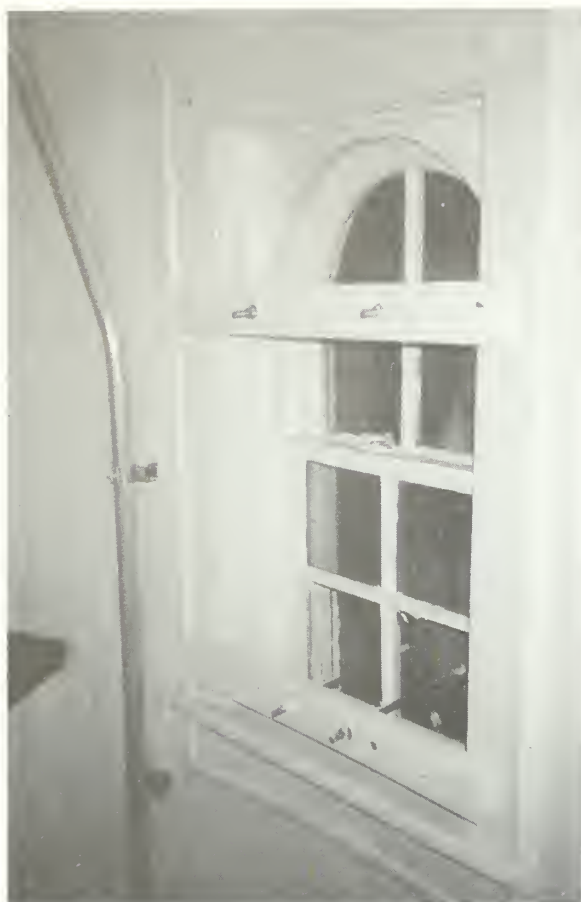
Figure 5. Interior view of the blocked window. If possible, a better solution would have been to raise the lower sash and lower the upper sash and pass the bolts through the openings.

- There are a number of ways to insert vented plywood panels into window openings to avoid damage to frame and sash. One common method is to bring the upper and lower sash of a double-hung unit to the midpoint of the opening and then to install pre-cut plywood panels on the inside face of the window using long carriage bolts anchored into horizontal wooden bracing, or strong backs (see Figures 4 and 5).

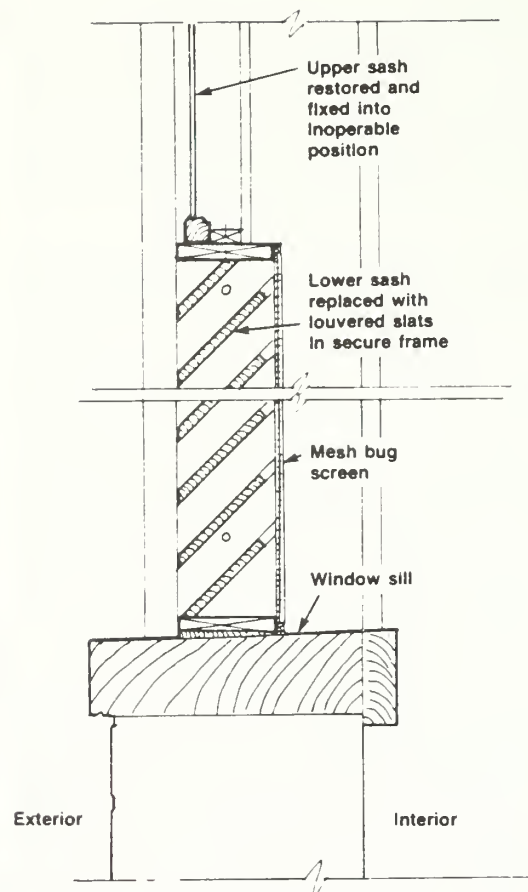
Figure 6. Detail of wood louver system designed to be inserted into lower sash opening after sash has been carefully removed. (Drawing by Thomas Vitanza, WPTC)

(To provide adequate ventilation, the louvered opening should have an area that is approximately half of the original sash opening.) When using this treatment, the sheeting must be ventilated to ensure that condensation, which could accelerate the deterioration of the window, does not build up between the panel and the window.

- The type of ventilation should not undermine the security of the building. The most secure installations use custom-made grills well anchored to the window frame, often set in plywood security panels. In upper-level windows vents formed using heavy millwork louvers set into existing window openings are another possibility (see Figure 6).

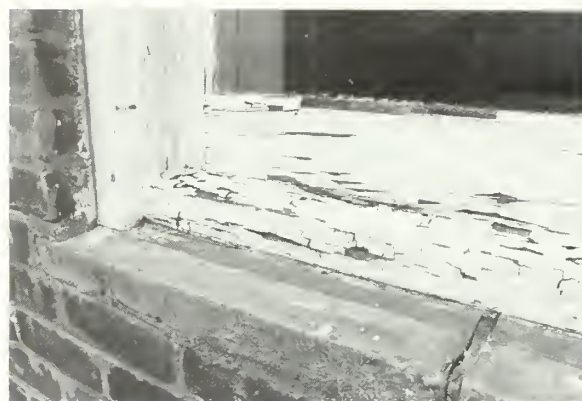
Figure 8. Deterioration of the bottom rail and sill on a wooden double-hung window.

- Figures 7 through 9 illustrate forms of deterioration typical to lighthouse windows. All of these conditions are repairable and do not require total replacement. The following guidelines are intended to aid in the repair of such deterioration.

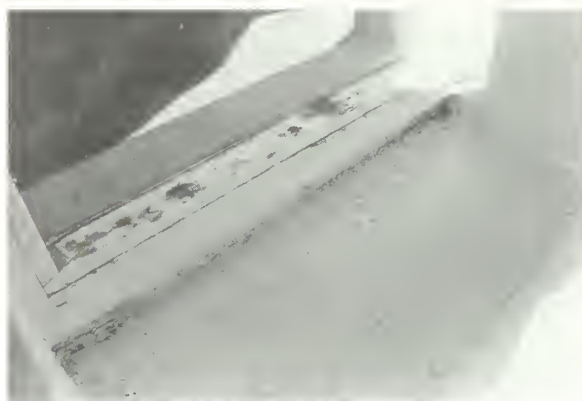
Figure 9. Rust occurring on the inside of the steel channel that forms the sill of this metal casement window.

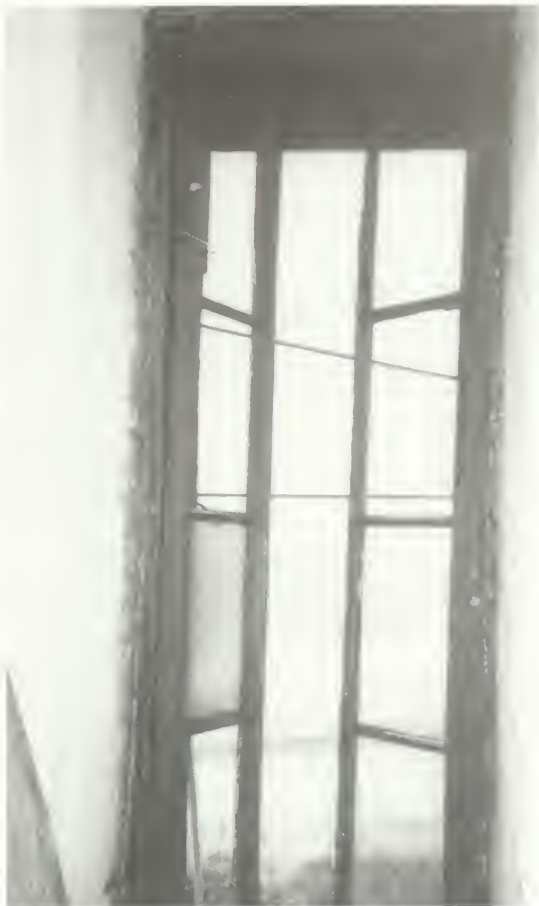
Figure 11. Example of a metal casement window in a lighthouse dating from the 1870s

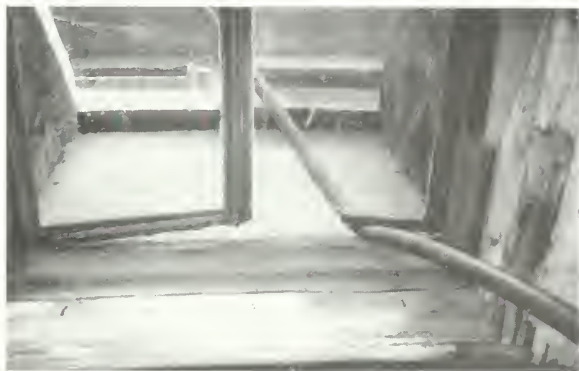
Figure 12. Close-up of severely deteriorated bottom rail of the same window in Figure 11. This condition can be repaired by splicing a new piece of sash

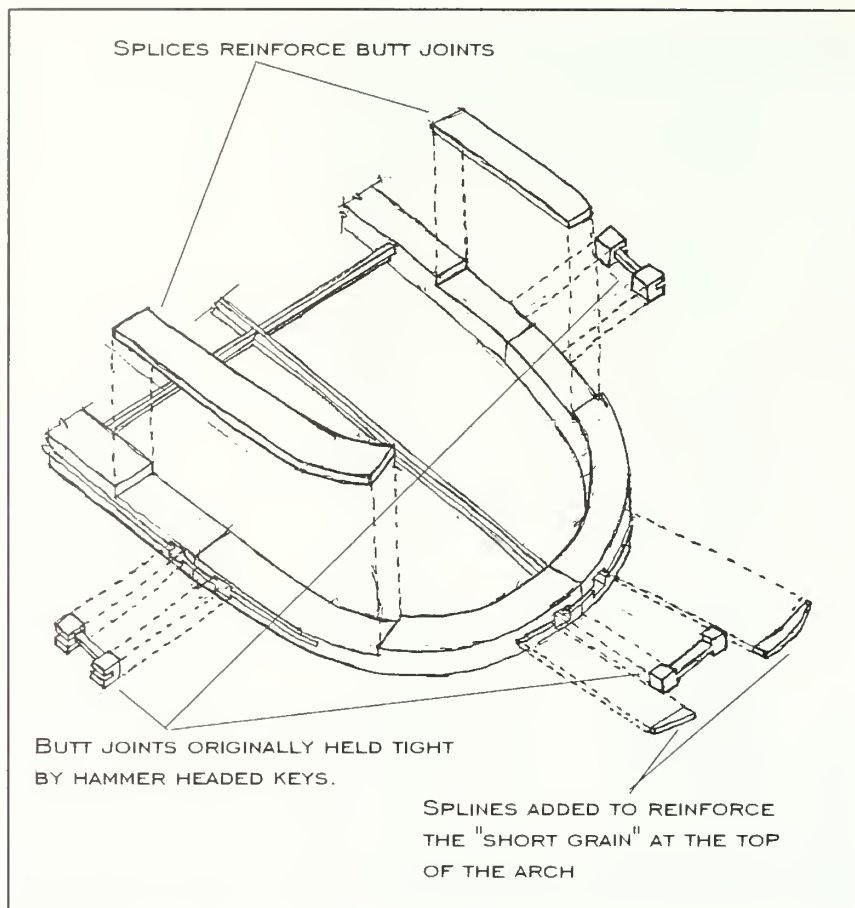
Figure 14. A wood window splice repair. (Illustration by Eric Ford, WPTC)

Deteriorated portions of wood windows can be effectively repaired using like-kind splices or dutchmen. Splicing of a wood member is required when a portion of the window, i.e., a frame rail, has been damaged or has deteriorated and only that portion needs removal and a new section attached in its place. All deteriorated material should be removed, and the end where the replacement member will be attached should be cut on a diagonal to increase the gluing surface area. The replacement member should match the existing members in grain orientation and in any existing shape or profile. The new member can even be made from matching salvaged stock. To attach the new member,

cut the end diagonally to match the existing member; then drill aligned holes in both members for reinforcing dowels.

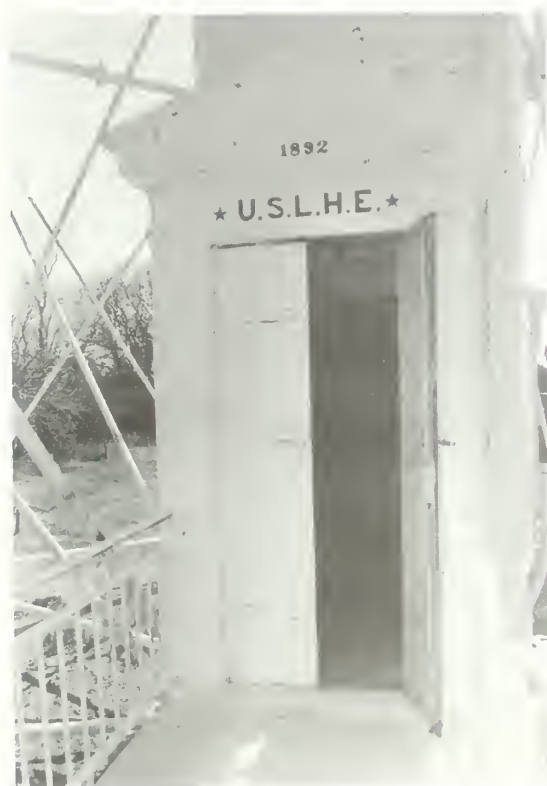
Figure 6. Close-up of the neoclassical, double-leaf, sheet-iron door at the Cape Charles Lighthouse, Smith Island, Virginia.

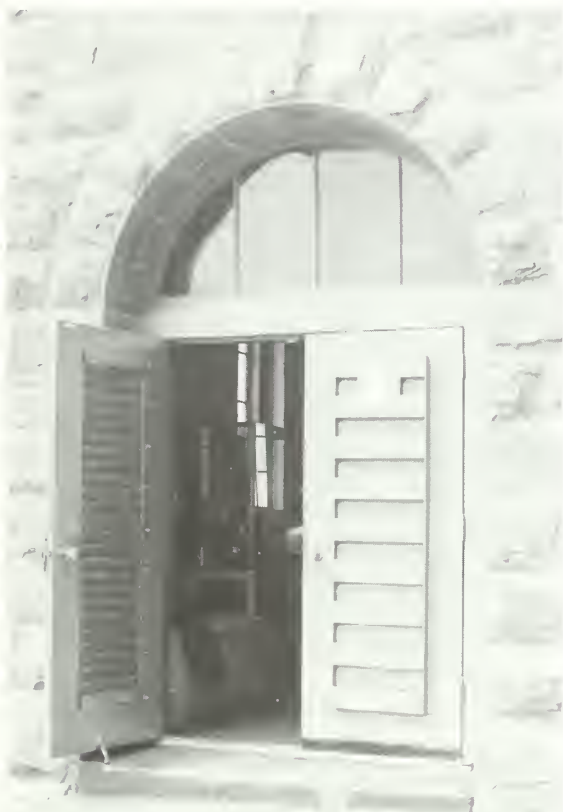
Figure 11. These louvered doors have been installed at Point Sur Light Station for security and ventilation. Note the baffles on the exterior and the screened louvers on the interior.

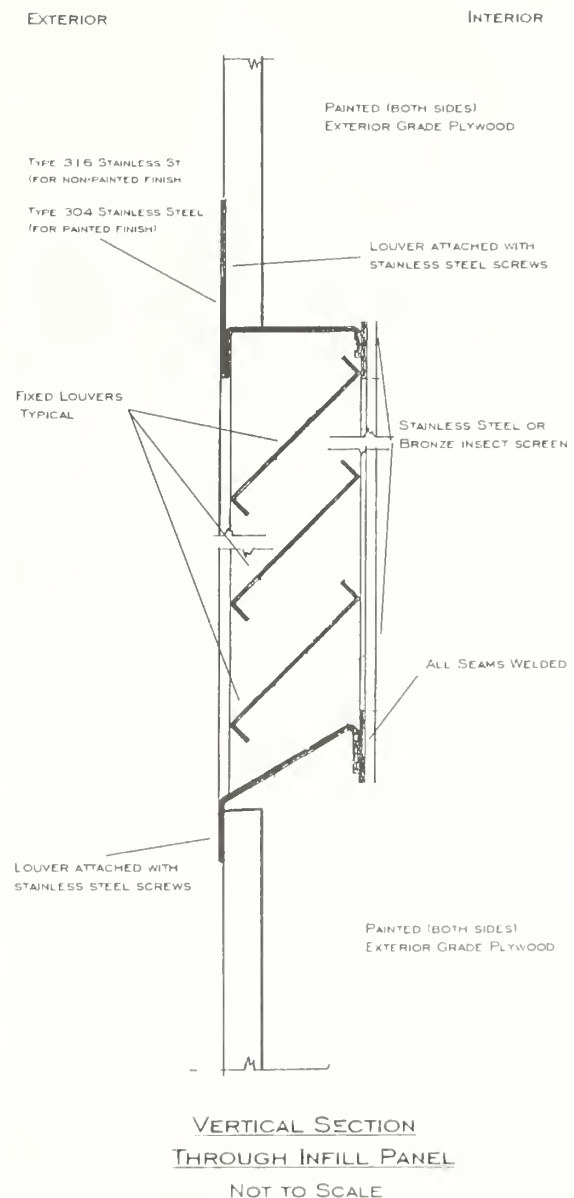
Figure 12. Typical detailing of a "storm proof" louver for temporary lighthouse doors. (WPTC image adapted from drawing from USCG-CEU Oakland Archives)

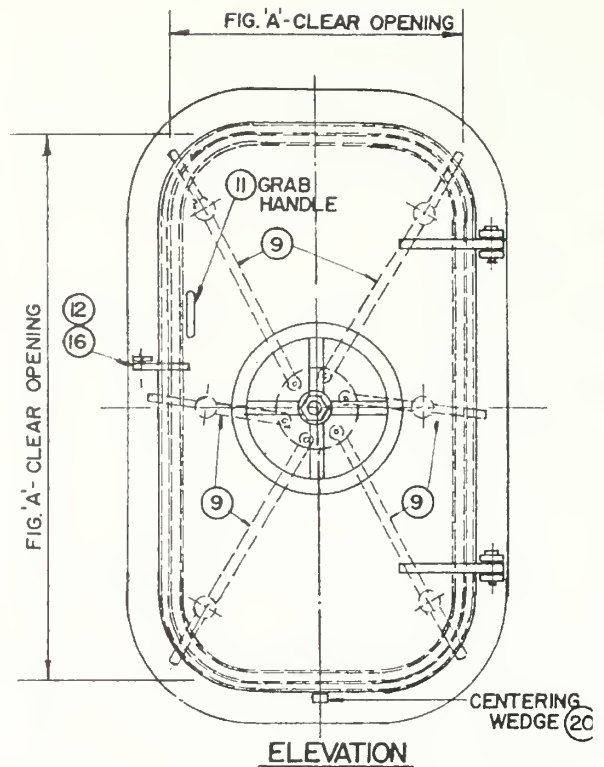
Figure 14. A shop drawing depicting the parts of the watertight 'ship' style door. (Drawing courtesy of Cen-Tex Marine Fabricators)

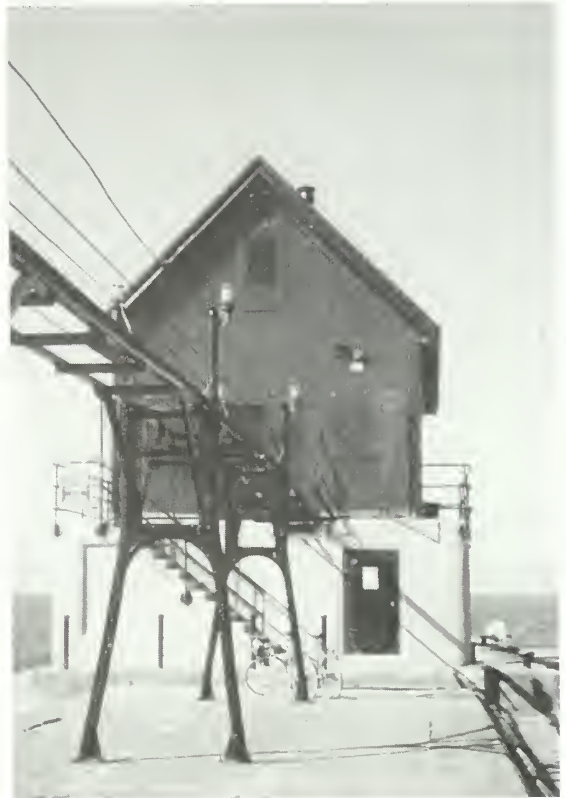
Figure 15. View of watertight 'ship' style door installation on the Grand Haven South Pierhead Front Range Light, Grand Haven, Michigan.

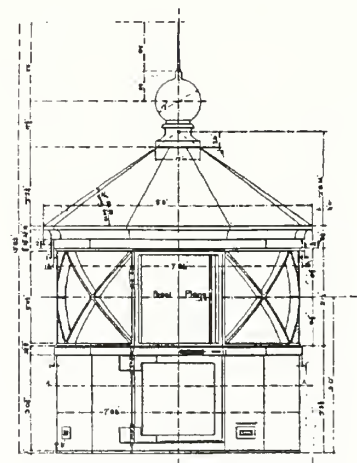
Figure 3. Illustration of the four standard lantern sizes used by the U.S. Lighthouse Establishment in the first half of the 20th century. Drawing assembled by WPTC from images dated 1898 and 1903 courtesy of USCG CEU Oakland.

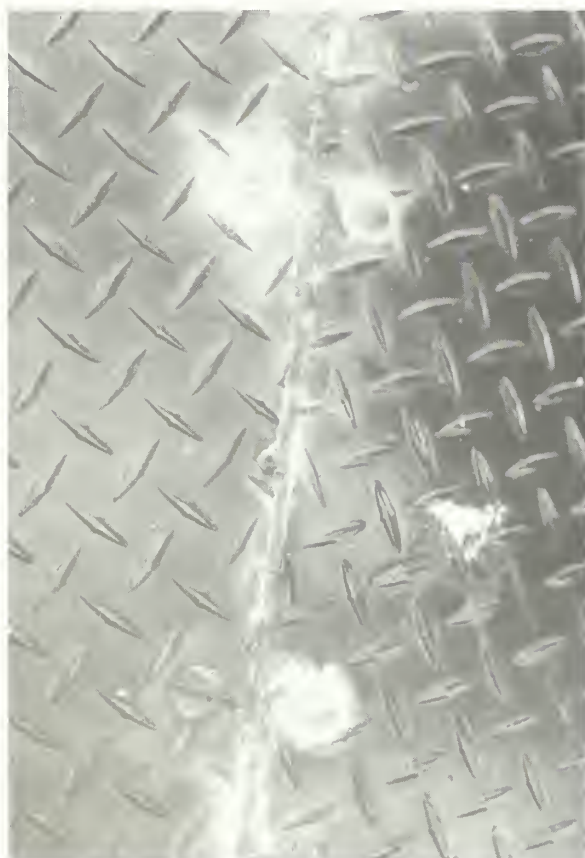
Figure 7. The white chalky residue around the steel bolt heads on this aluminum deck is the by-product of the corrosion occurring at these connections.

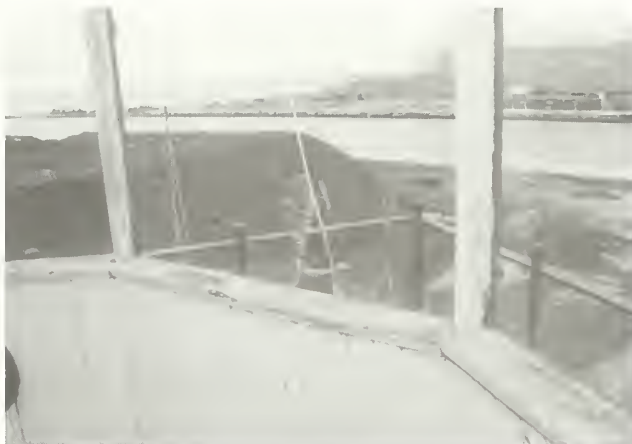
Figure 16. This lantern glass has been damaged by rock-throwing vandals. The resulting hole is allowing rain and insects to enter the lantern.

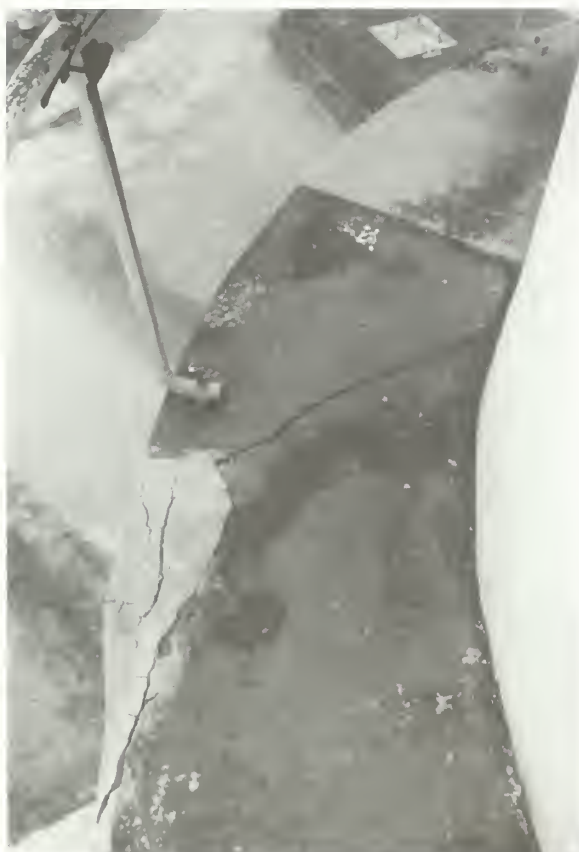
WPTC photo

Figure 19. The repair made to this stone gallery deck has begun to deteriorate; moisture penetration is occurring. This condition should be addressed before mothballing.

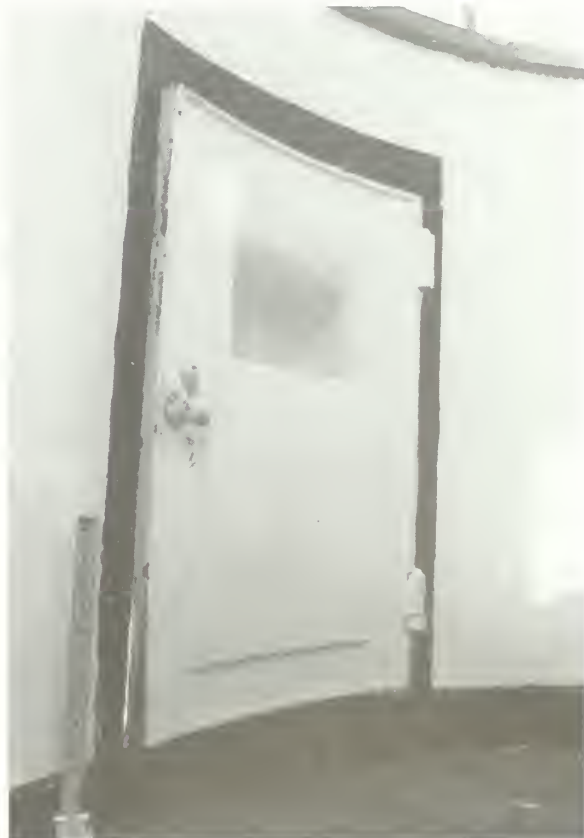
WPTC photo

Figure 20. Close-up of a vented parapet hatch in a fourth-order lantern. The hatch should have a good seal and still remain operable. The built-in vent should also be kept open to maximize ventilation of the lantern and tower.

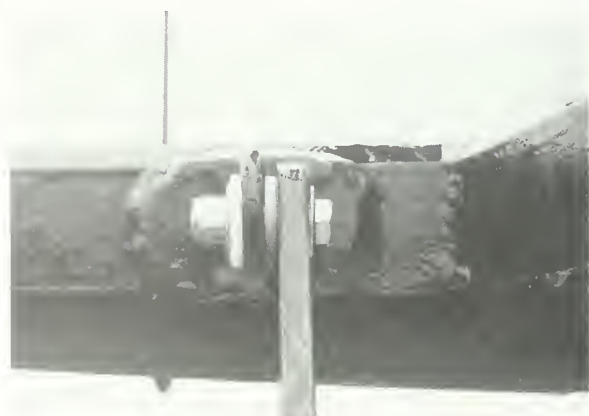
Figure 25. This is a view of a typical dissimilar metal isolation solution; the steel ladder post (vertical member in the center of the image) is isolated from the aluminum lantern gallery deck with nylon washers. The bolt chosen for this application is made from Type 316 stainless steel.

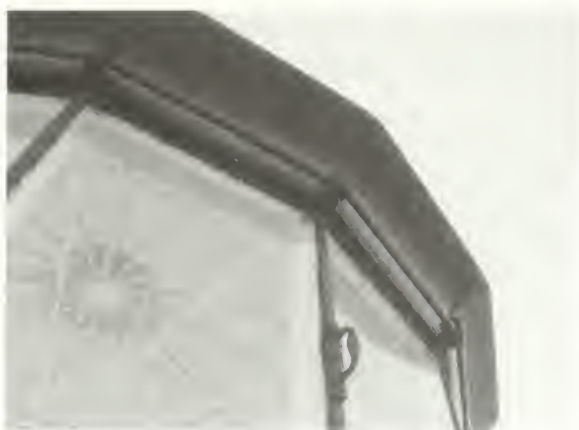
Figure 30. Close-up of a first-order lantern that retains its lantern glass; note the clarity.

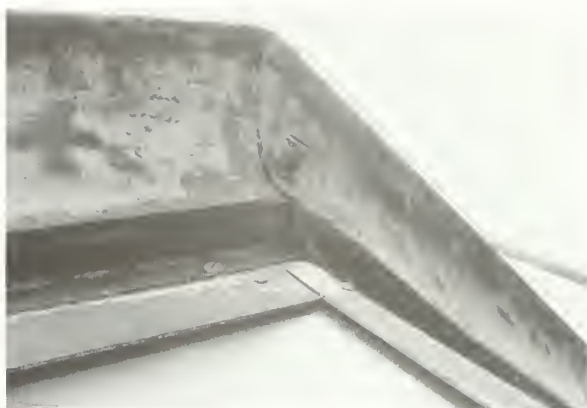
Figure 31. View of built-in gutter spout on a copper roof.

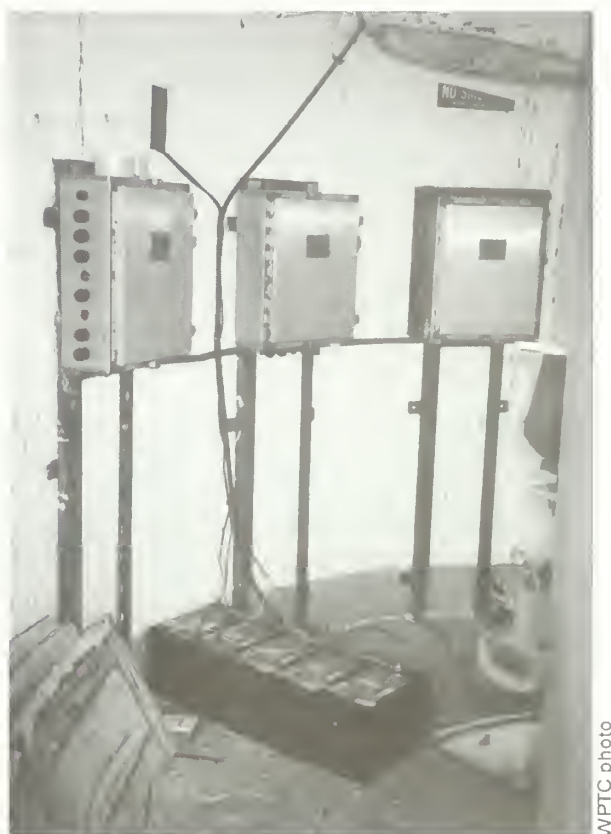
Figure 33. To minimize damage to historic wood beadboard panelling, these new panels should have been installed on a sheet of plywood attached to the historic wood beadboard panelling in four locations. These batteries stored on the floor should be in containment boxes in case the batteries leak.

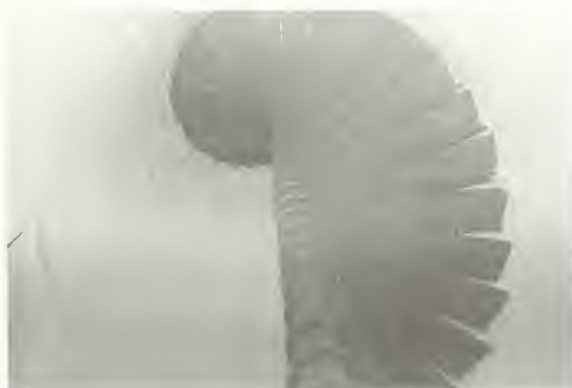
Figure 2. Utilitarian light tower interior at Cove Point Light Station, Maryland.

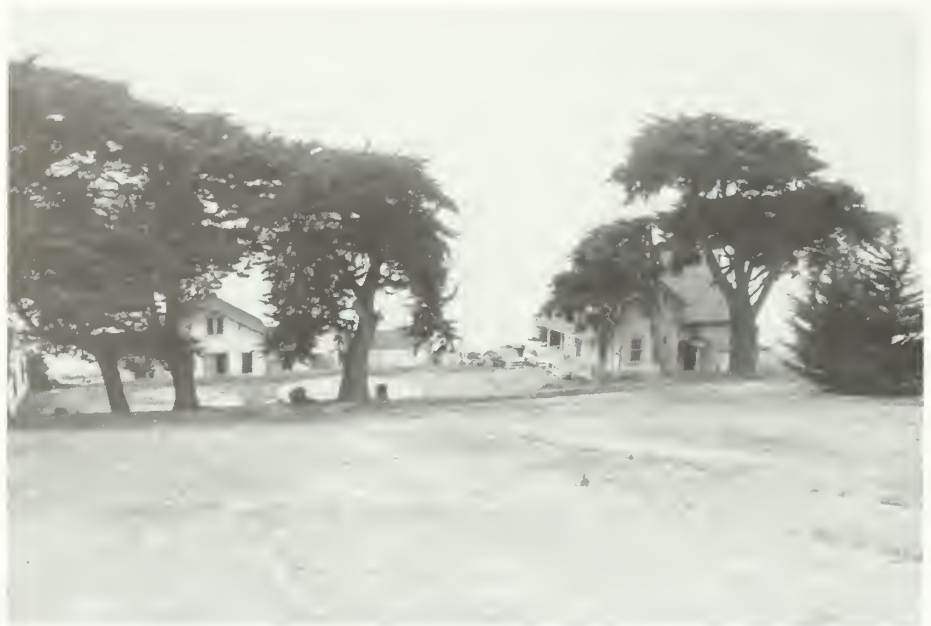
Figure 9. View of a highly intact historic light station in California. All principal structures that made up the light station are intact including the large concrete rain water catchment (in the foreground) and the below-grade wood cisterns (just the lids are visible in the center of the photo) used to store the rainwater to produce steam for the fog signal. The preservation of a site at this level of integrity is essential to understanding the relationship of the light station buildings and their contribution to the station's overall operation.

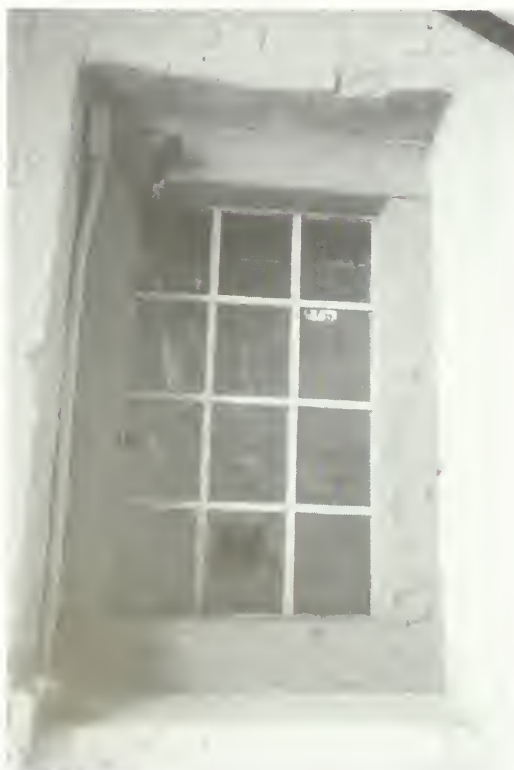
Figure 2.

Figures 2 through 5 illustrate successful replacement window designs. These solutions can be easily adapted to most historic lighthouse window designs. During the rehabilitation of the lighthouse shown in Figures 2 and 3, the metal multiple-light windows were reproduced based on the remnants of the original windows and on historic lighthouse construction documents from a lighthouse built in the same region during the same time period. During the restoration of the window opening, the granite window frame was also replicated from remnants found in another window opening. Even the tooling pattern on the stone surface was reproduced. A single-leaf, vertical-plank shutter can be seen on the lighthouse in Figure 3. This detail was also based on existing evidence. Not only is this detail historically accurate, but it has protected the lighthouse during hurricane-force winds.

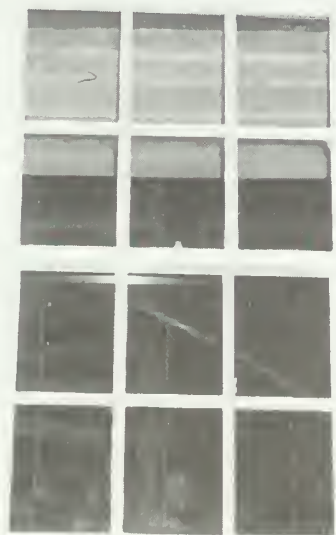
Figure 4.

The wooden, double-hung, six-over-six window were reproduced from historic photographs. Subtle details such as molding profiles and hardware that could not be determined from historic photographs were based on lighthouses constructed by the same builder during the same time period. Figure 4 shows a close-up of the exterior side of the window; note the simple detailing and lack of profiled trim. These characteristics are typical of lighthouses constructed before the Civil War. Figure 5 shows the lighthouse after the installation of the replacement windows.

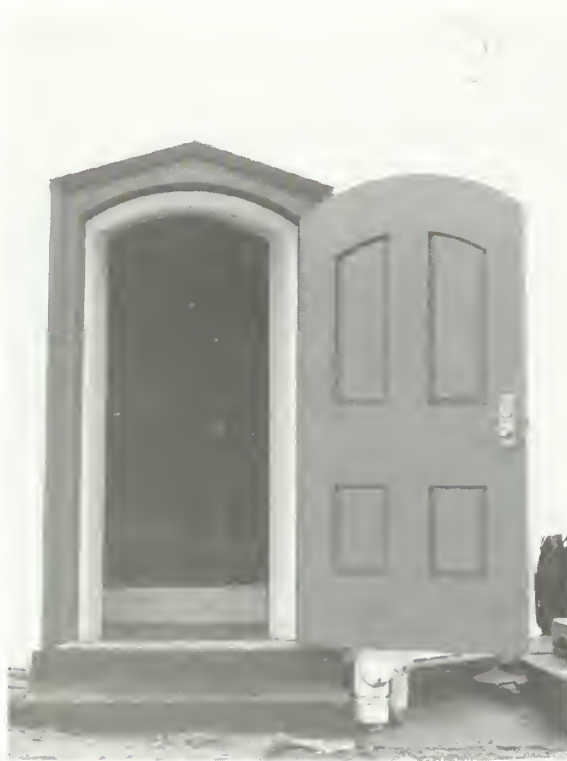
Figure 6.

Figures 6 through 9 are examples of successful replacement door designs. The solutions displayed here can be easily adapted to most historic lighthouse door designs. The wood replacement door design in Figure 6 was based on wood-frame and panel-construction-style doors commonly used when this lighthouse was constructed in 1928. The only difference made to the c. 1928 design was the upgrade of the hardware to stainless steel components. This door design was based on information from historic photographs from the U.S. Coast Guard archives and

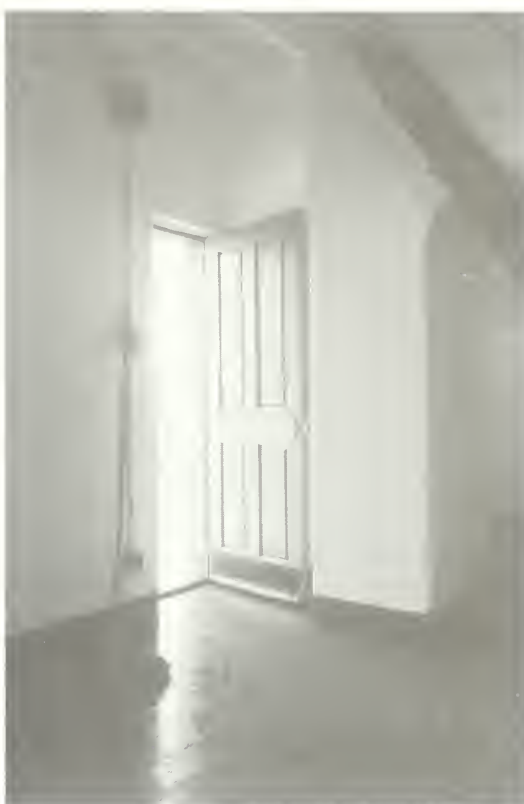
Figure 8.

Wood frame and panel door: Partial remains of a wood frame and raised panel was found inside the structure during rehabilitation. This evidence was used in conjunction with historic construction drawings to develop this design. The door shown in Figure 8 was made by a local mill from Douglas fir. The hardware is all stainless steel to minimize maintenance and to extend the serviceable life of the door. As an added weather protection measure, a traditional drip edge has been installed along the bottom of the door to shed water away from the door opening.

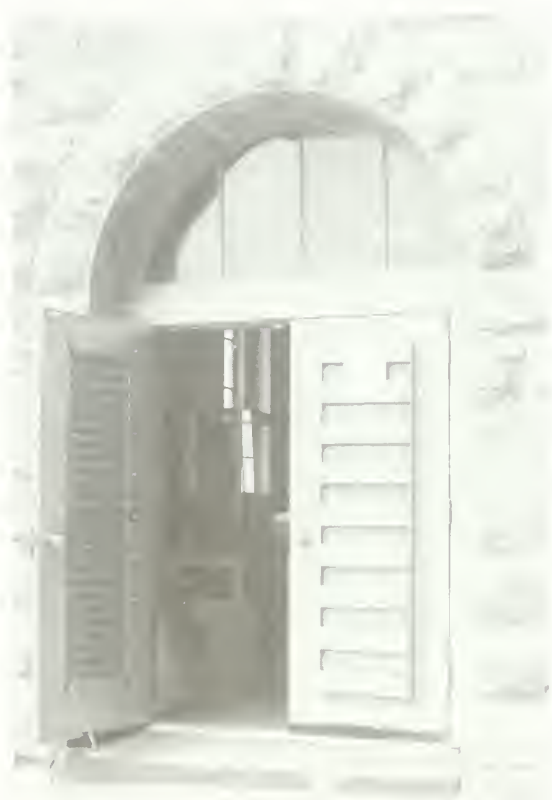
Figure 9.

The door in Figure 9 is designed to minimize the problems at a lighthouse that does not see regular visitation because of its remote location. Four factors took precedence over historical correctness: weathertightness, ventilation, security, and maintenance. The door had

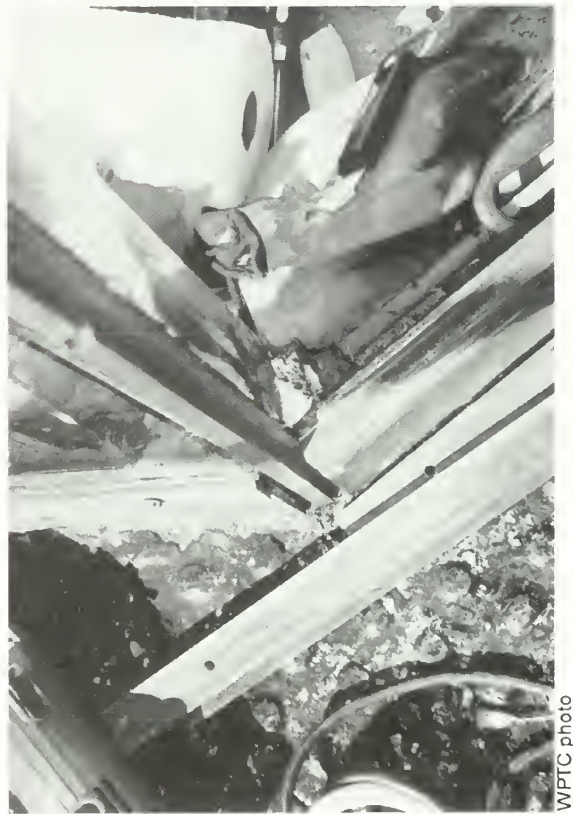
Figure 14. Following placement of the restored bronze mullion, the fenestration is ready to receive the new glazing system.

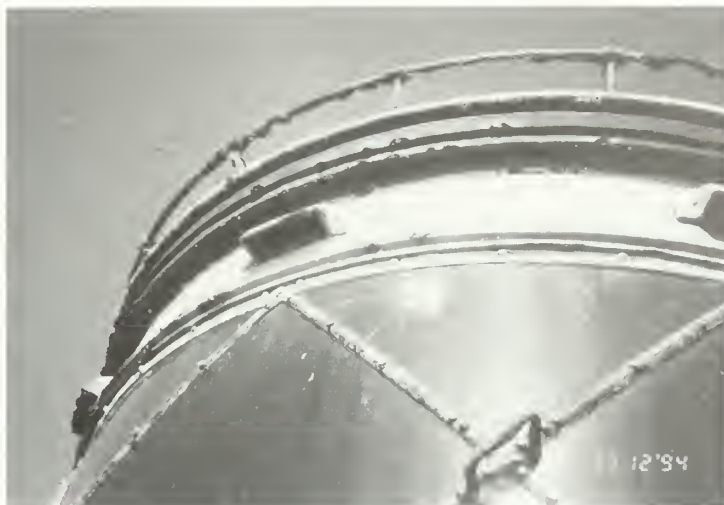
Figure 18. Close-up of the deteriorated conditions of the Anacapa Island Lighthouse before rehabilitation.

Civil Engineering Unit Oakland's Facility Inspection Team originally identified the need for this rehabilitation during an inspection of the lighthouse in 1992. The entire lighthouse was in such poor condition that it was labeled the worst lighthouse on the West Coast (see Figure 18). The inspection team initiated the paperwork that identified both the need for the rehabilitation and funds. Although most large Coast Guard projects normally take five years before being funded, Anacapa was in such poor condition that it was given a high priority; design work started within two years. In late 1994 the architect assigned to the project made his first site visit. The architect determined that the best way to repair the badly deteriorated cast-iron lantern house was to remove it from the concrete tower via heavy-lift helicopter and transport it to the mainland for overhaul. Further investigation, however, disclosed several insurmountable obstacles; he was forced to consider a more conventional but far from easy onsite rehabilitation of the entire lighthouse. The following scope of work was identified and budgeted for \$325,000:

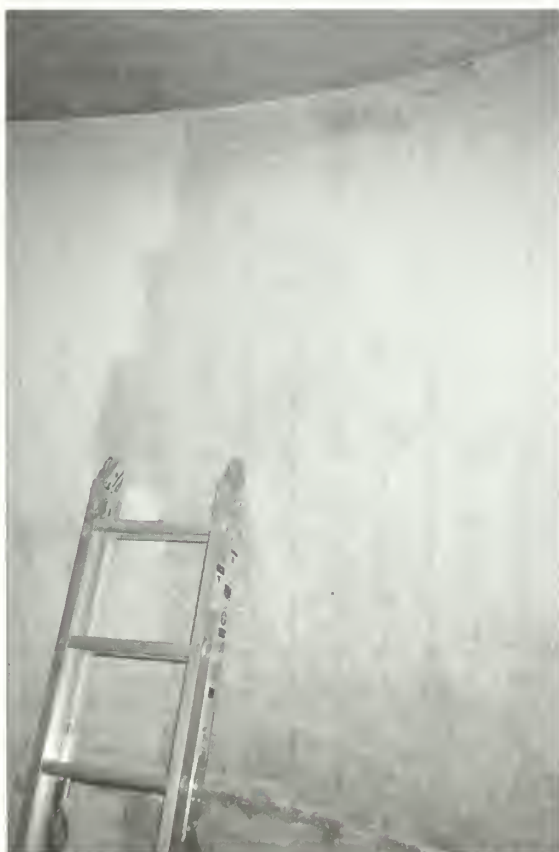
Figure 24. The interior paint was effectively removed using needle gun scalers, without damaging the concrete as evidenced by the visible impressions of the formwork boards.

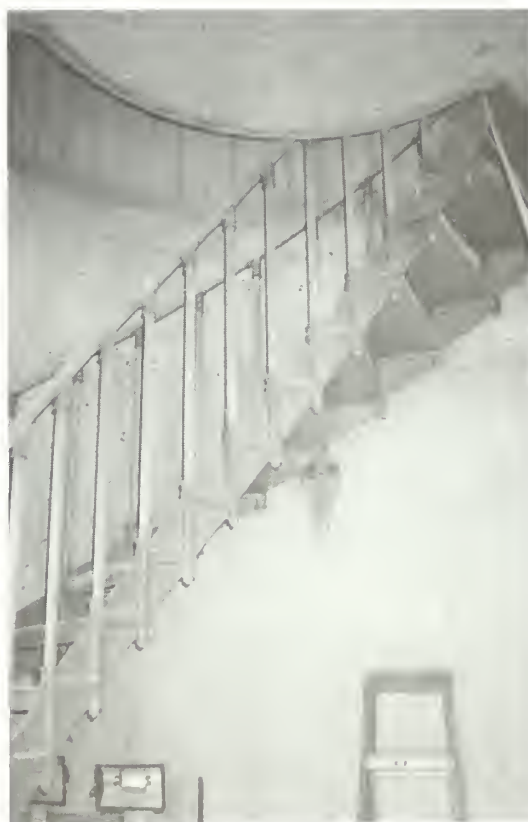
Figure 25. After the cast-iron stairs were blast-cleaned, they were rinsed to remove all traces of lead dust; flash rust immediately formed (as seen in this photo). Before painting, this light rust was removed with wire brushes.

expected and did not pose a problem (see Figure 25). All surfaces were then wire brushed, prepped, and primed by a three-man team who only prepped what they could prime within an hour. Although the primer used was designed for use over flash-rust, we did not want to chance a coating failure.

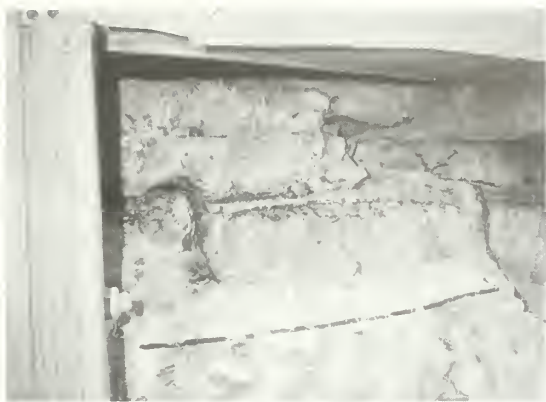
Figure 28. Close-up of the damaged concrete gallery deck after the loose concrete has been removed and before the damaged concrete was repaired using pressure-injected epoxy grout.

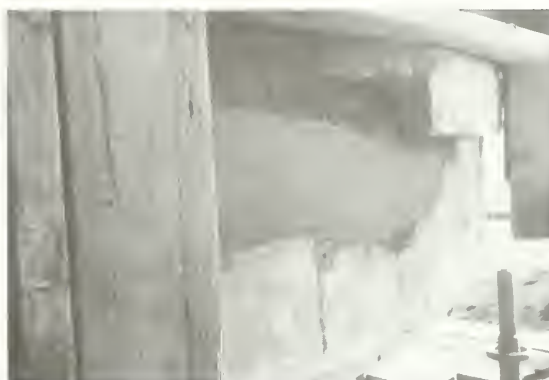
Figure 29. The first application of the mortar patch material to the damaged concrete.

broken concrete; the project was already over budget. We decided to do a pressurized epoxy injection and fill all the voids. The area was prepped and pumped full. The outer three inches were left unfilled so the two-part mortar patching compound could be used to restore the damaged area (see Figures 29 and 30).

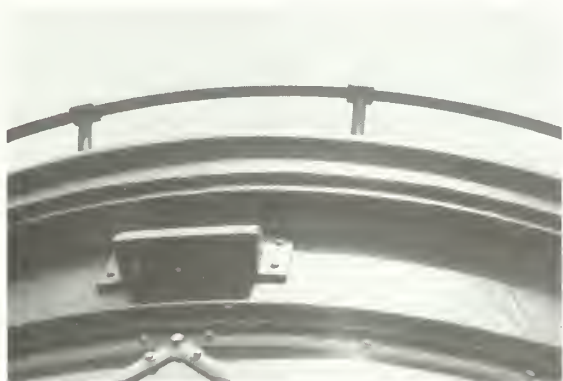
Figure 31. Close-up of the finished metal work on the lantern.

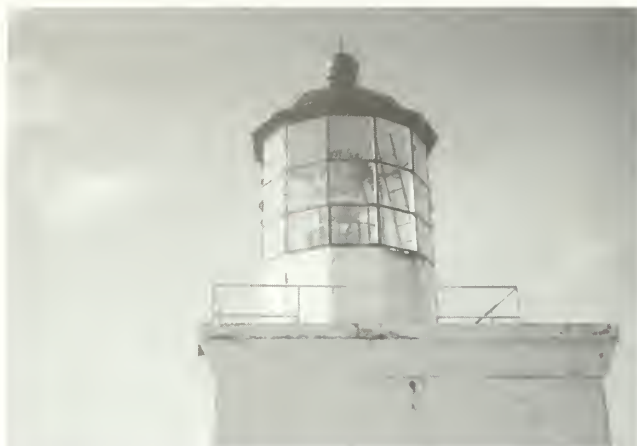
Figure 33. Point Bonita Lighthouse before rehabilitation; note missing gallery deck and holes below between the bottom of the lantern glass and top of the service room wall.

The poor condition of Point Bonita was first noted by the Officer in Charge of the San Francisco Aids to Navigation Team (ANT). His request prompted a site visit to Point Bonita in January 1993 to conduct a facility assessment and provide advice on how to repair the structure (see Figure 33). The original plan was to stop the water from entering the lighthouse and let Civil Engineering Unit (CEU) Oakland do the overall renovation in a couple years. But further investigation indicated the need for more immediate repairs, using self help-funding and the ANT personnel. The project soon grew into a full renovation that took six months and \$75,000 to complete.
